Manhole Inspection Summary

Manhole # S06GG2005MH

Insp Date: **7/15/06 10:46 AM**

Location Address: **7131 BOXFORD RD**

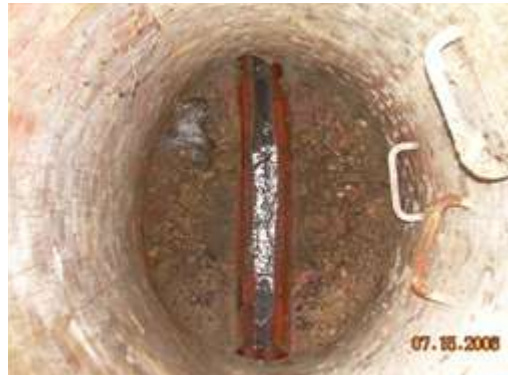
Top View

Adjustment and Barrel infiltration.
Evidence of surcharge - Bench debris.
Corroded steps.

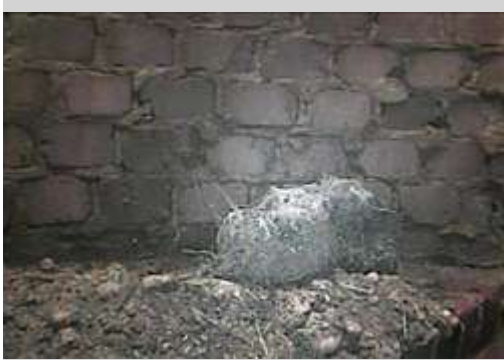
Defect

Bench debris. Barrel deterioration and infiltration.

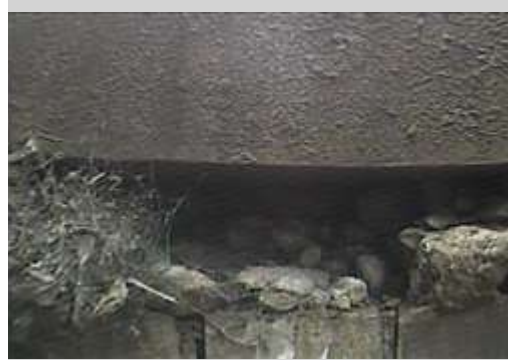
Defect

Frame leaks. Adjustment deterioration,
loose brick, and infiltration.

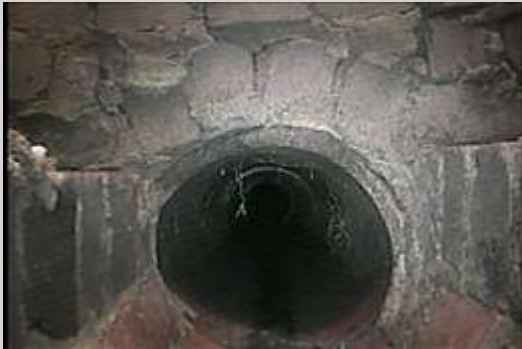
8 in. Circular Gravity Sewer Pipe Out @ 12 O'Clock

Pipe Material: **Clay** ☐ Pipe Lined

Invert Depth: **8.10** (ft.) Flow Characteristics: **Slow**

Infiltration: **Evidence** Pipe Seal Cond: **Unknown**

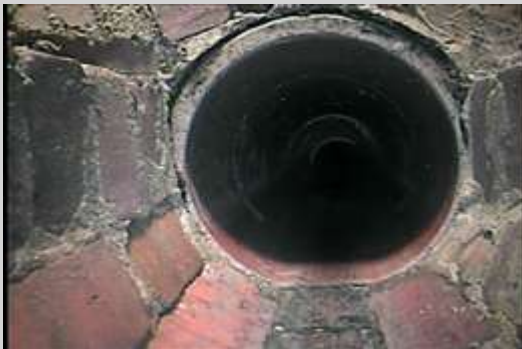
8 in. Circular Gravity Sewer Pipe In @ 6 O'Clock

Pipe Material: **Clay** ☐ Pipe Lined

Invert Depth: **7.99** (ft.) Flow Characteristics: **Slow**

Deposits: ☐ None ☐ Mud ☐ Sludge ☐ Debris ☒ Grease

Silt Depth: **0** (in.) Deposits Extent: **Light**

Infiltration: **Evidence** Pipe Seal Cond: **Unknown**
